Shuttle Wing Leading Edge Root Cause NDE Team Findings and Implementation of Quantitative Flash Infrared Thermography

Presenter:

Eric Burke

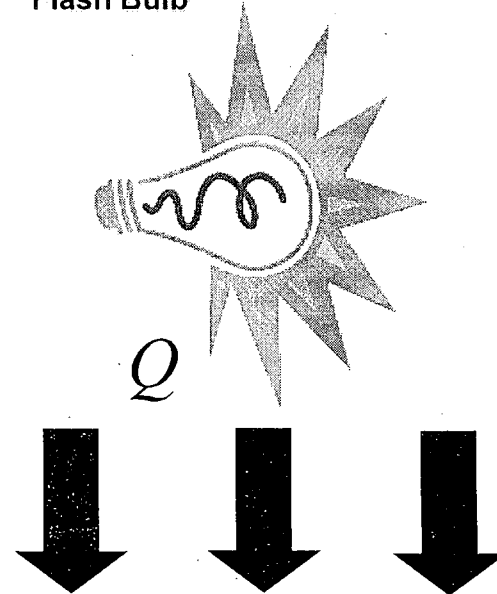
Flash Bulb

- Three main modes of heat transfer.
 - Conduction
 - Radiation
 - Convection
- Flash thermography is mainly concerned with only the conduction of the heat through the part being inspected.
- For a semi-infinite, defect free sample, the time-dependent surface temperature response to an instantaneous heat pulse is given by

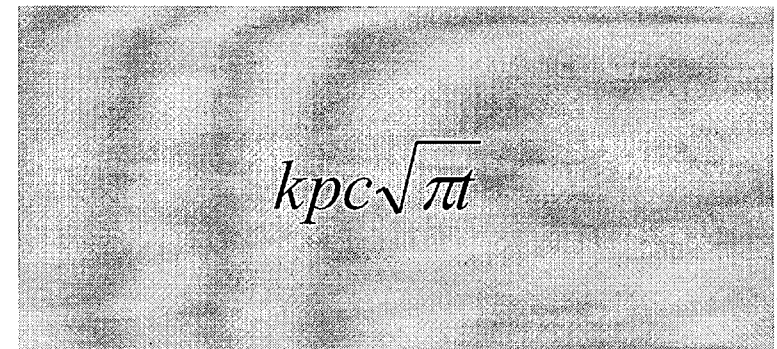
T_{Surf}

- Where Q is the input energy per unit area, k the thermal conductivity, p the density, c the specific heat of the sample and t is time.

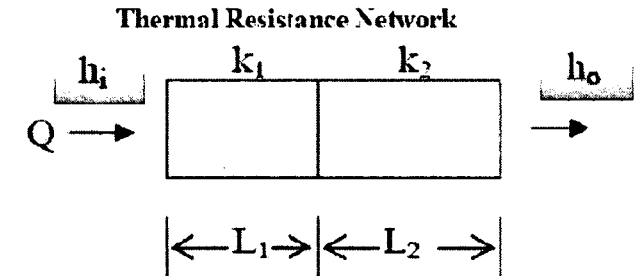
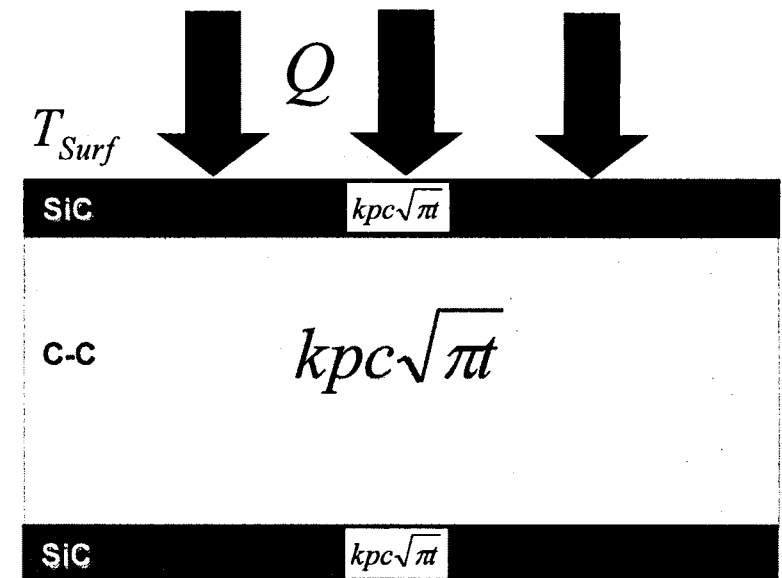
- Given the basic equation complex systems are simply modeled by viewing each section of the material as it's own thermal body.
- These individual systems are dependant on each other and can be modeled in series.
- Due to the layered system of reinforced carbon carbon it is most simply modeled by a two part system.
- Properties for SiC:
 - (k) Surface Normal Thermal Conductivity for SiC = 15.6 W/(m K) (Note:~4.5x Higher than C-C)
 - (k_y) In-plane Thermal Conductivity for SiC = 24.3 W/(m K)
 - (Q) Specific Heat for SiC = 0.69 J/(g K)
 - (p) Density for SiC = 3.2 g/cm³
- Properties for C-C:
 - (k) Surface Normal Thermal Conductivity for C-C = 3.46 W/(m K)
 - (k_y) In-plane Thermal Conductivity for C-C = 5.39 W/(cm K)
 - (Q) Specific Heat for C-C = 0.75 J/(g K)
 - (p) Density = 1.6 g/cm³

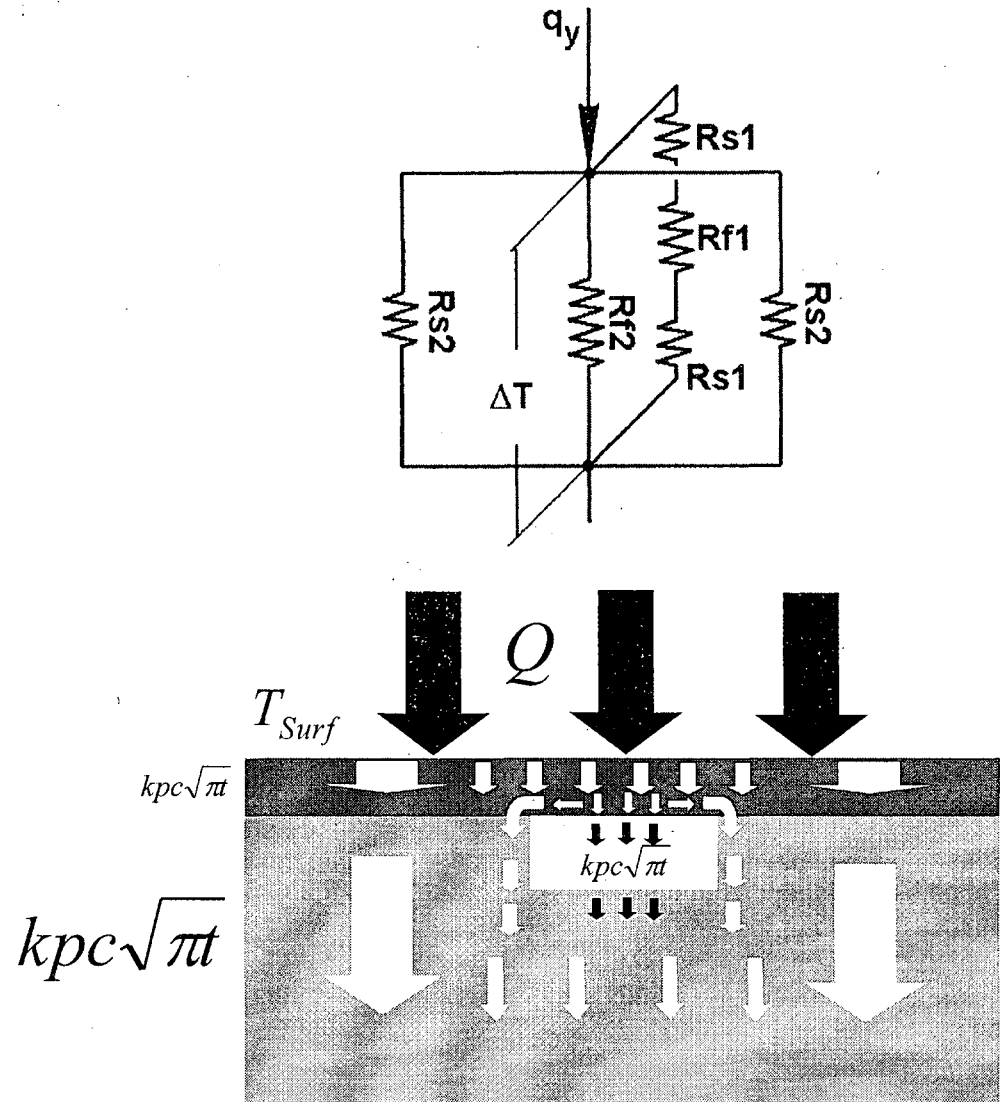
- The addition of a defect changes the dynamics of the problem.
- The addition of a defect can be considered three ways.
 - Void – No Heat Transfer
 - Some Conduction – Air Gap
 - $k = 0.07 - 0.026 \text{ W/ (m K)}$
 - A partial combination of air conduction and material conduction simply referred to as contact resistance.
- Heat energy now has several paths it can follow.
- Some of the heat flows though the gap and some flows around the gap. By flowing around the gap the in-plane (k_y) determines the rate of heat flow.

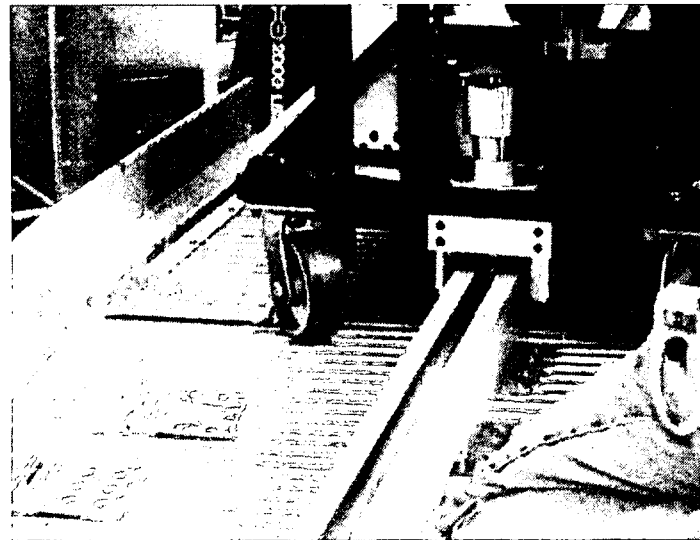
Positioning Cart Slotted
in GSE Railing System

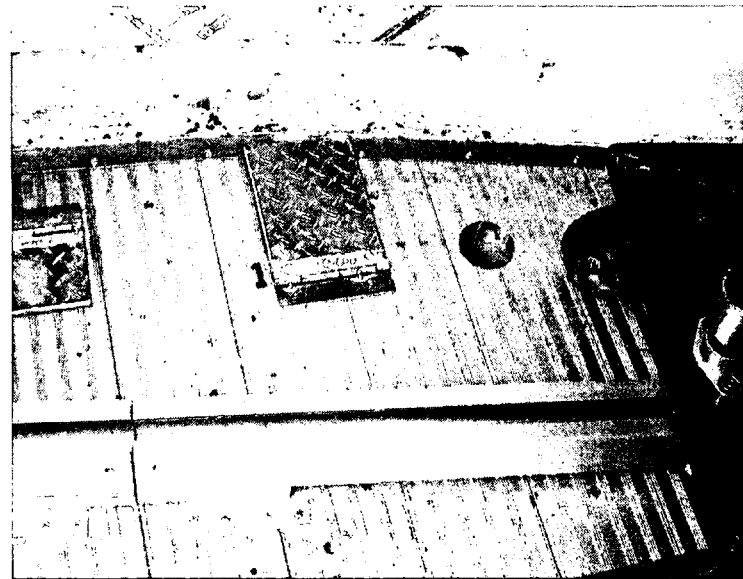
GSE Railing System
Connection

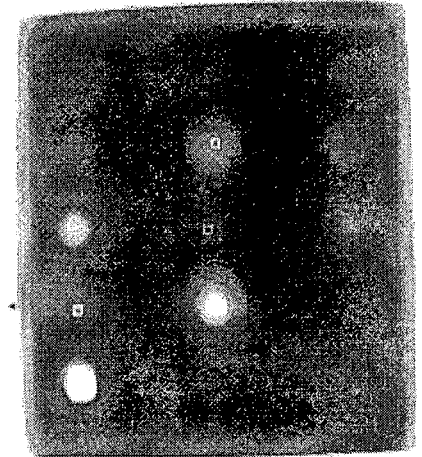
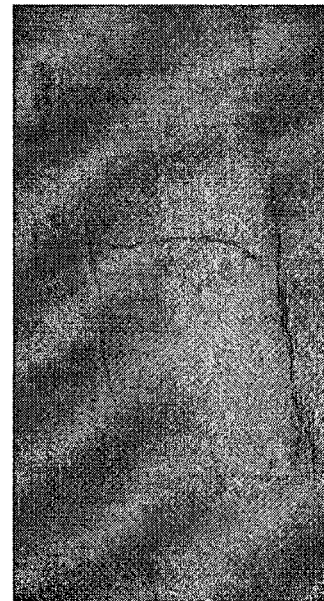
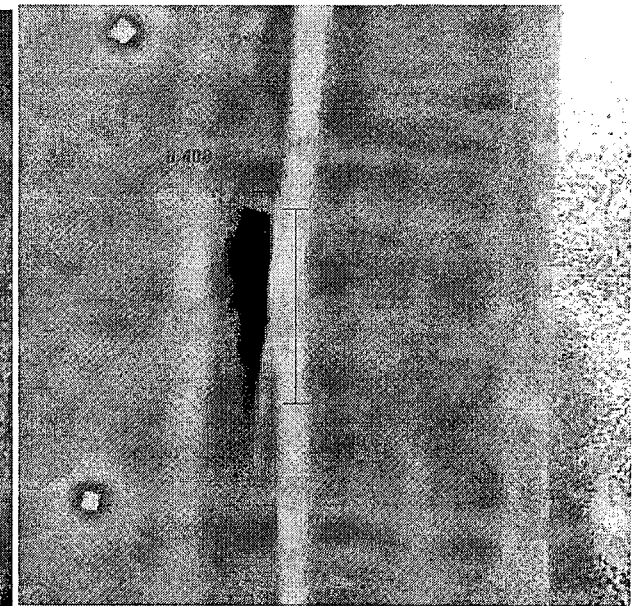
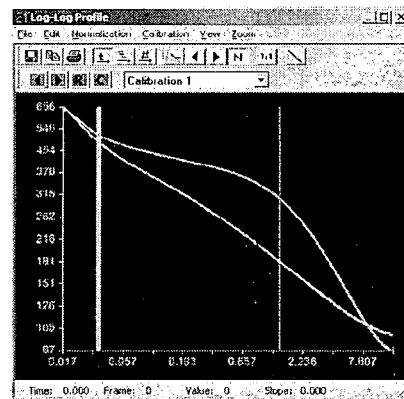
- To this point IR has mainly been a qualitative technique.
- As we have seen that the presence of defects causes changes in the way that heat flows through a given part.
- Comparing the image contrast levels the Level 3 operator can easily see defects in reinforced carbon panels.
- One of the short coming of this method is that the current standards contain defects that are significantly deeper than the current mode of failure.
- Majority of the acreage inspection
- Common Tools
 - T-T Curves
 - Raw Image
 - 1st Derivative
 - 2nd Derivative

Calibration Image

Photo

Second Derivative

Time Temperature Curve

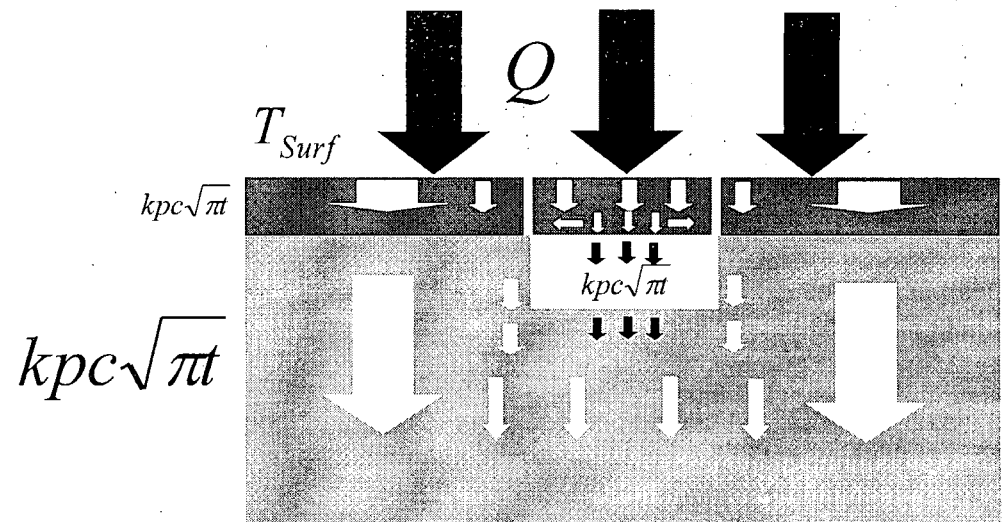
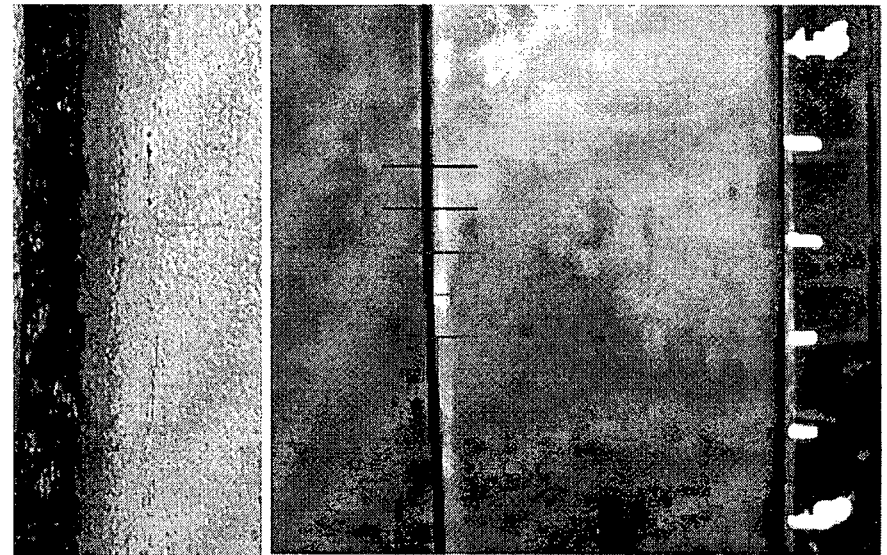
- Cracks in the surface of the material will cause the heat in that area to be forced through the underlying defect. This will cause a higher than normal heat build up in that area.
- Loss of lateral heat flow is commonly observed around cracks and craze cracks.
- In a thermographic image cracks and craze cracks generally form very defined lines.
- Occasionally there will be a surface defect that causes a hot spot in the image. These hot spots occur very early in time and do have a very long (persistent) existence. Flakes are noted but not considered a defect.

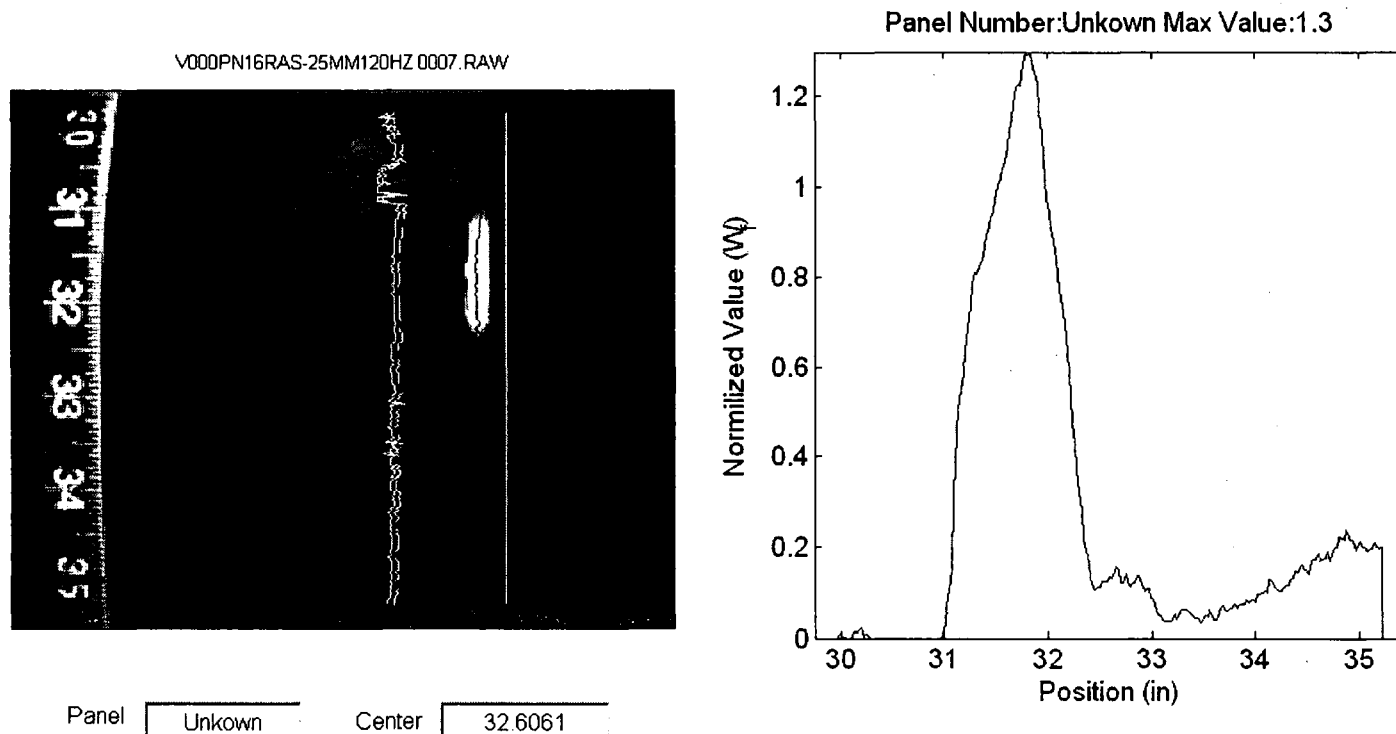
- Using a quantitative method allows for the formation of a metric that has information on the intensity of the defect that cannot be gained by qualitative comparison.
- The establishment of the Normalized Value is a method for establishing a quantitative number for a given indication.

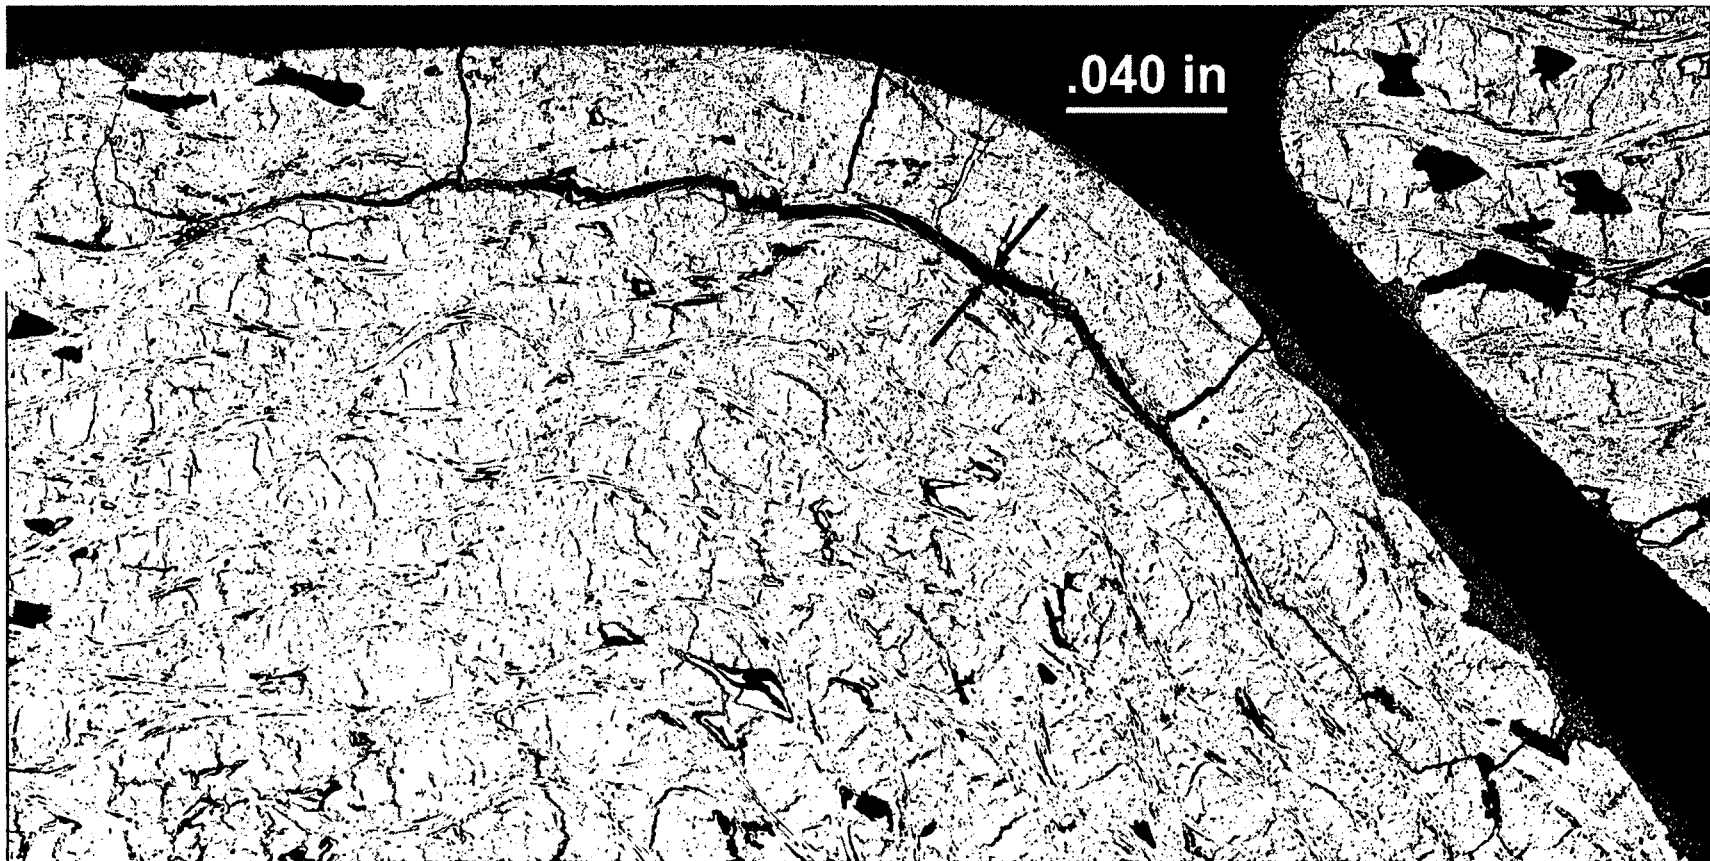
- Given that the main mode of failure is occurring at the SiC – CC interface a specific region in time in which several frames are averaged. This image window opens 0.5s after the IR flash occurs and lasts 0.08s. These frames provide a good view in time to find this defect type.

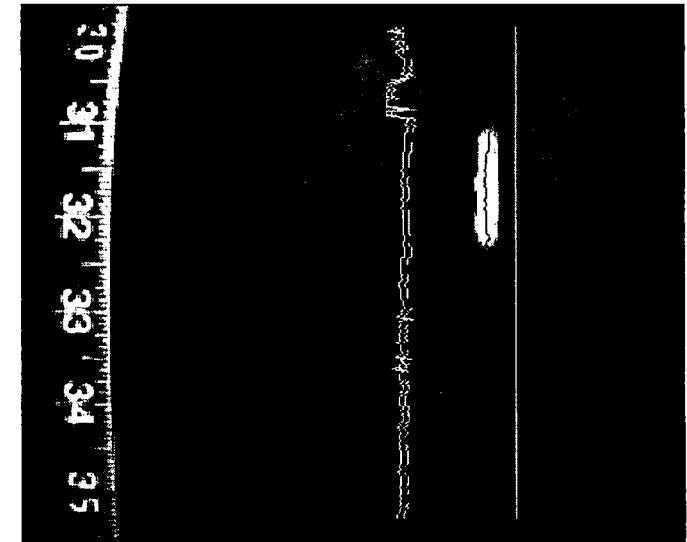
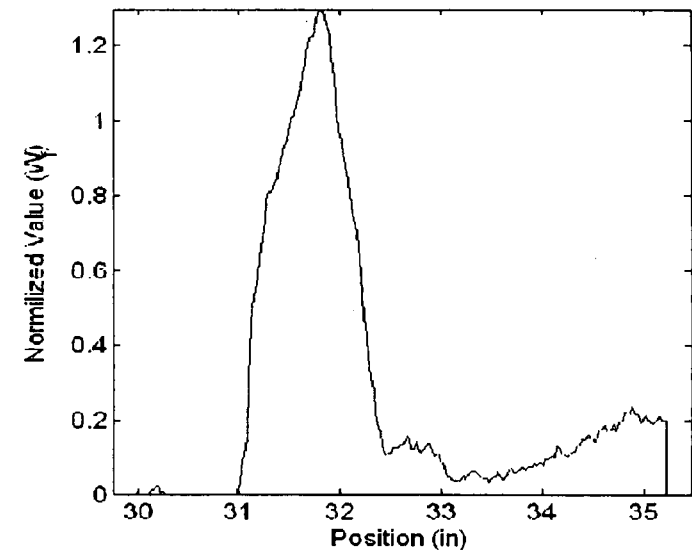
Panel Number:Unknown Max Value:1.3

- Many variables can affect the way that a thermographic image is taken. In order to mitigate these affects a reference value is required.
- Due to the geometric curvature heating affect or the presence of a t-seal step and gap the slip side of all panels have a colder region next to the joggle. This cooler region is established as the minimum line (Green)
- From the minimum line the algorithm searches in the horizontal direction to find the maximum value (red).
- Once a maximum has been found a reference value is calculated by stepping in the horizontal direction and averaging a band of values.

$$W_f = \frac{P_{\max}}{P_{\text{ref}}} - 1$$

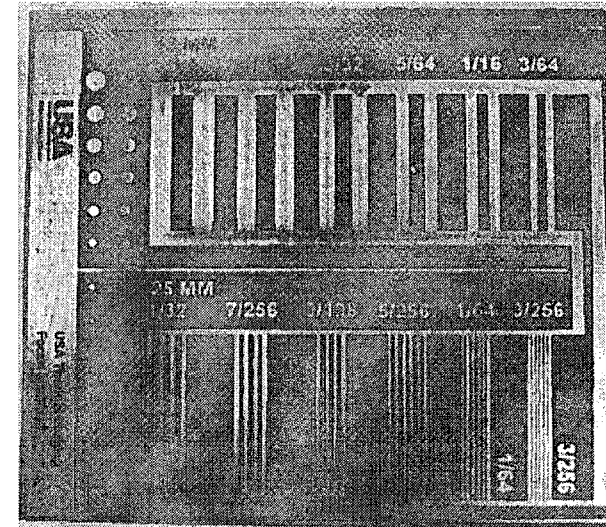
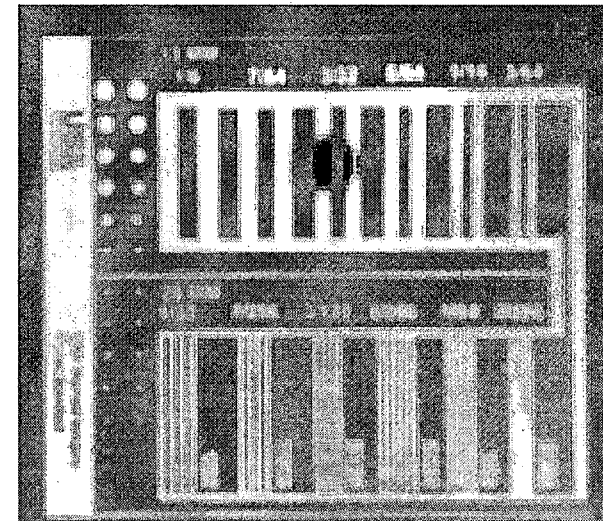
Image Quality Indicator

- Several environmental conditions can affect the establishment of the normalized values. The main variables that have been identified are:
 - How Sharply the camera is focused.
 - The angle of the hood relative to the panel being inspected.
 - Location of the defect in the field of view.
 - Material Variability (SiC Thickness, Delamination Depth)
- By shifting to quantitative technique vs. a qualitative technique the IR inspection team has had to tighten it's inspection method to provide more repeatable Wf values.
- Changes thus far include:
 - Specifying the orientation of the hood per shot.
 - Implementation of a Image Quality Indicator.

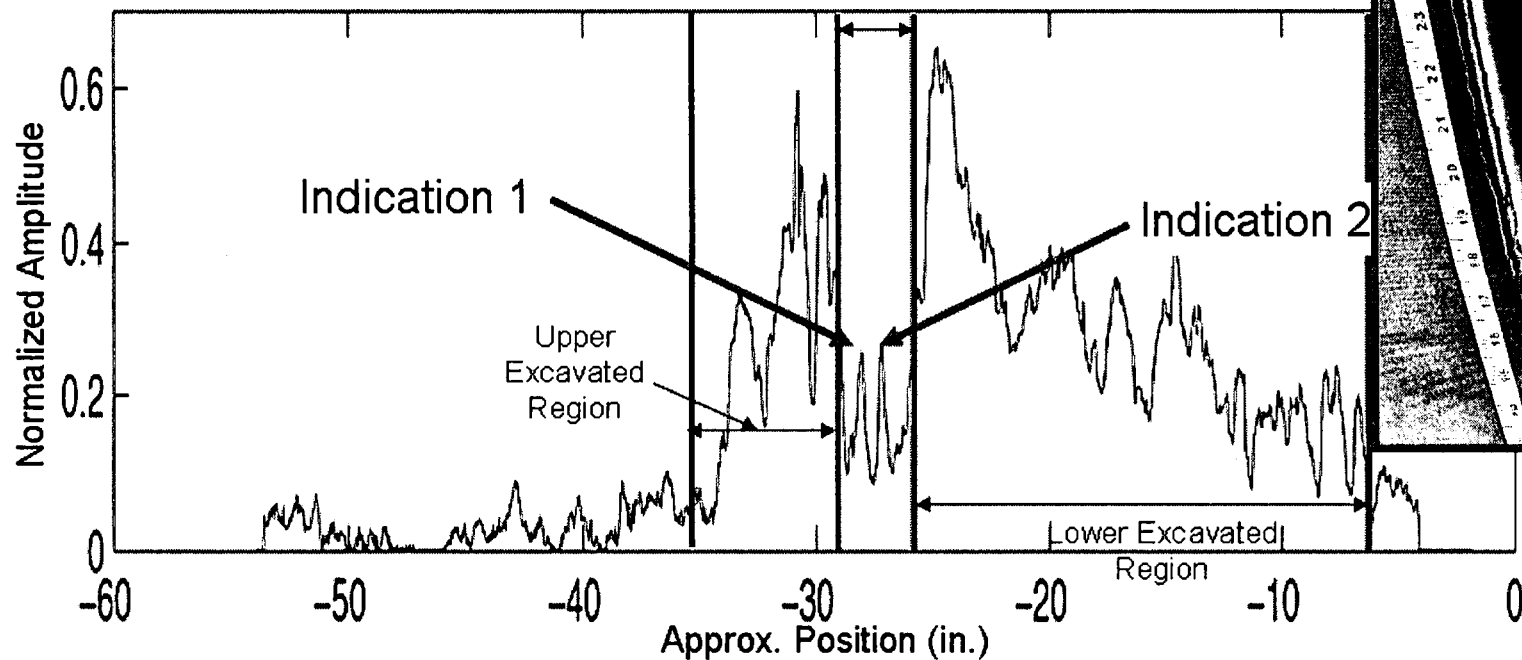
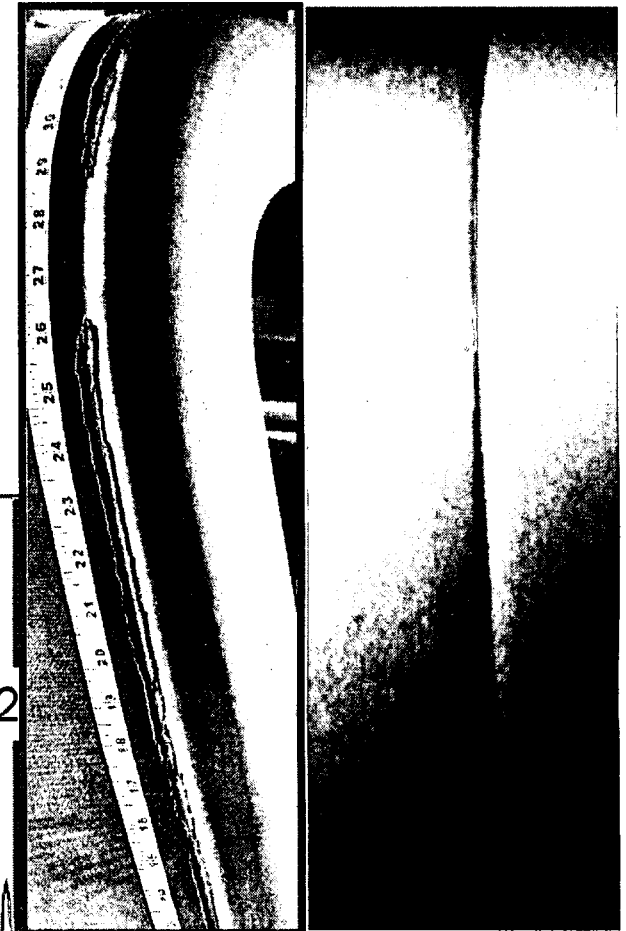
- Panel 8R Post Flight STS-114 had a very strong thermal indication a majority of this indication was masked by the t-seal and was later removed by dental picking.
- A small section of this area was left in tact and assumed to be delaminated.
- In this region the line scan value was 0.20

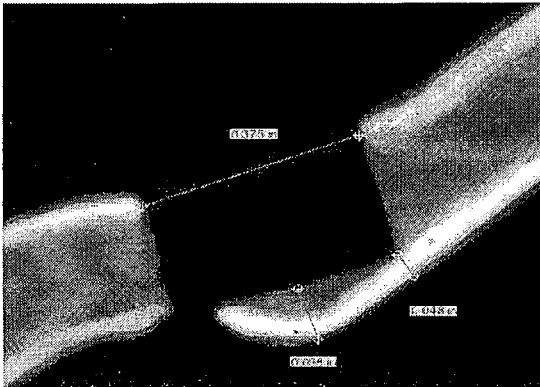
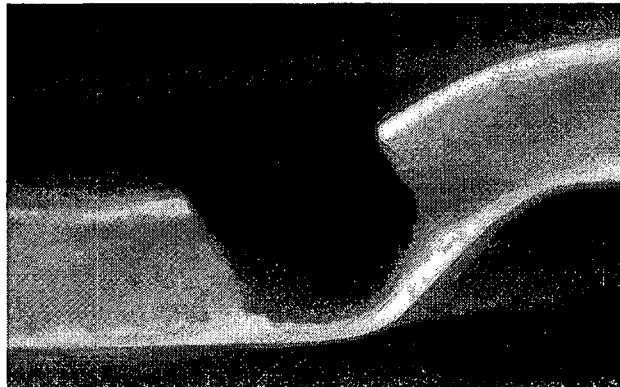
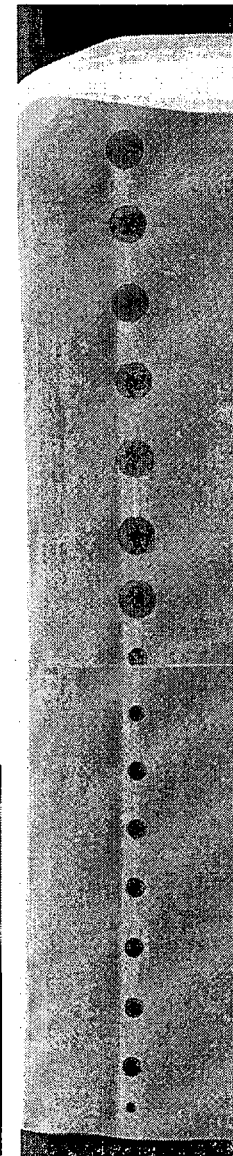
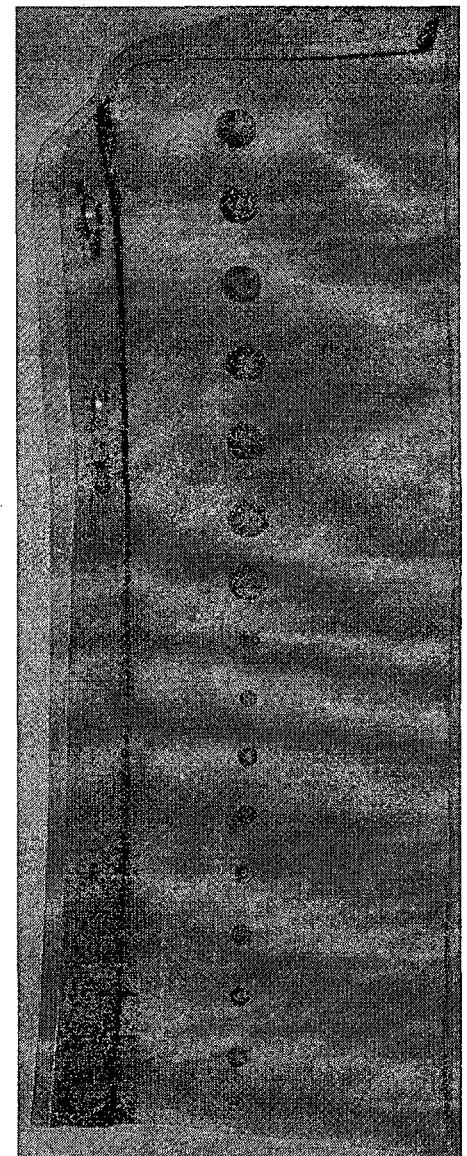
- Round bottom holes are being used in the joggle region in order to accommodate the curvature of the slip region.
- The thermal signature of a round bottom hole will be different than that of a flat bottom hole. It is not known yet if an appropriate adjustment factor can be established.
- Inspection of these samples will be completed both with and without the presence of the T-Seal.
- In addition a study is currently being conducted to quantify the affect of the T-Seal gap on the magnitude of the Normalized Values.

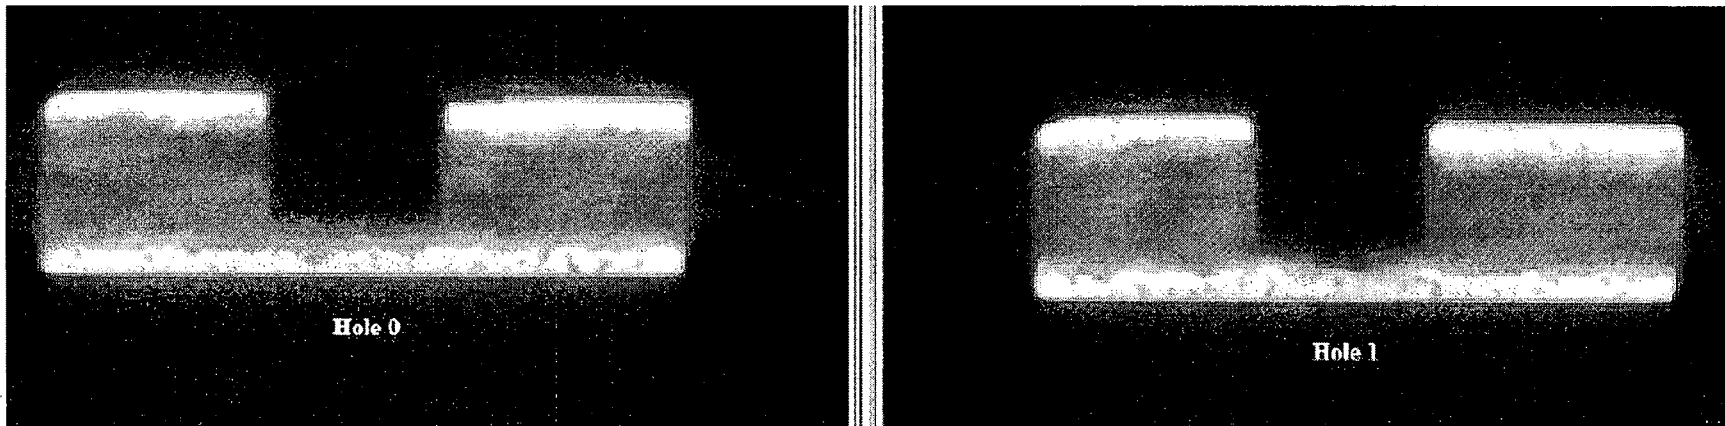
- Laser ablation is a technique where a tuned laser is applied to the residual carbon material in order to oblate it away. The laser is tuned such that it will remove C-C and not SiC.
- Mound laser photonics took there first cut at cleaning out one of the larger holes on 6L. Due to concerns that they where getting to close to the SiC coating layer we had the part shipped back to KSC to perform an intermediate CT to see how much material remains.
- The laser ablation worked fairly well although there is some small about of residual material remaining. Removing the remaining material did have a significant effect on the normalized response of the standard.
- We are proceeding to procure funding and are going to perform the laser ablation technique all the holes in the standard.

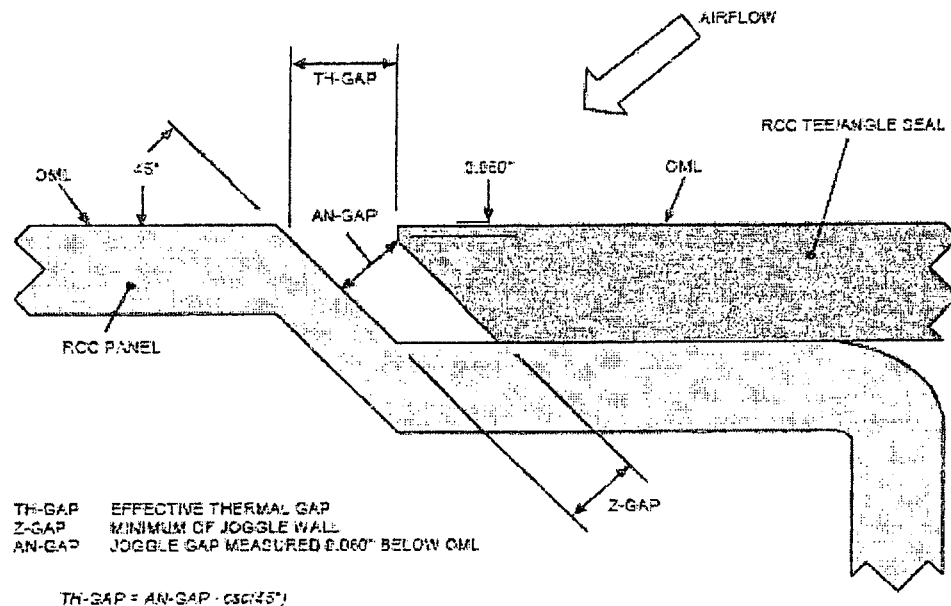
- Gap is established by using USA step and gap shims. The shims come in different color coded thicknesses.
- Using combinations of the shims 5 gap variation are studied: 0.025", 0.075", 0.125", 0.175, 0.225".
- Panel and t-seal are clamped together with shims in place to maintain spacing during testing. Shim sets were specially trimmed to fit in the gap along the joggle region and placed in the gap but out of the FOV of the Thermal Camera. Gaps were also checked during testing between shots by running a shim along the gap.

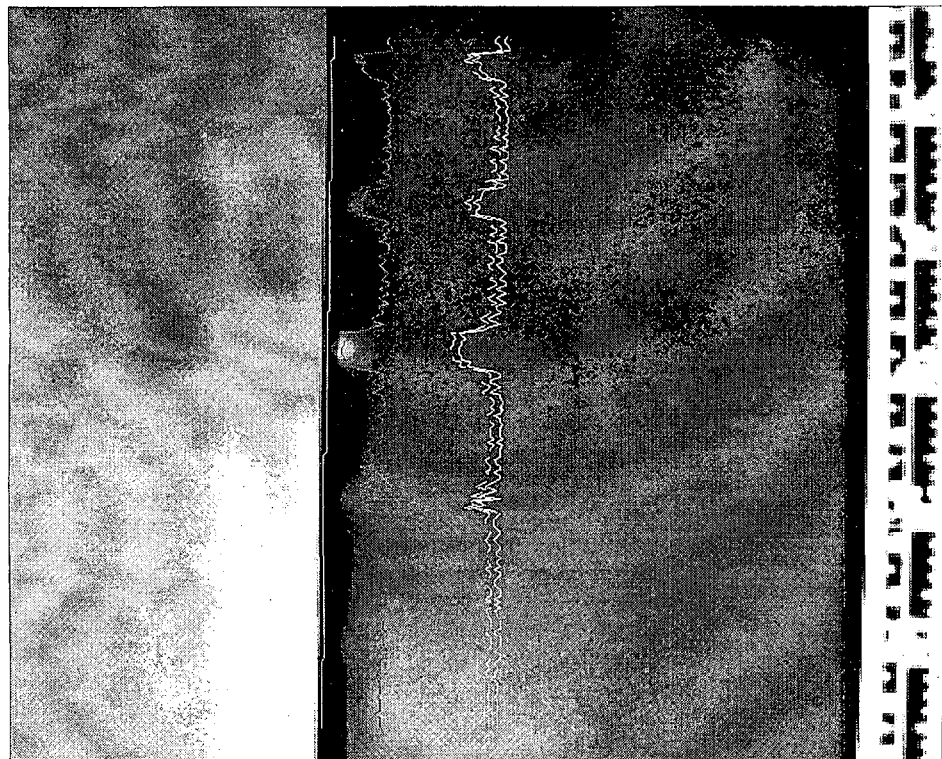
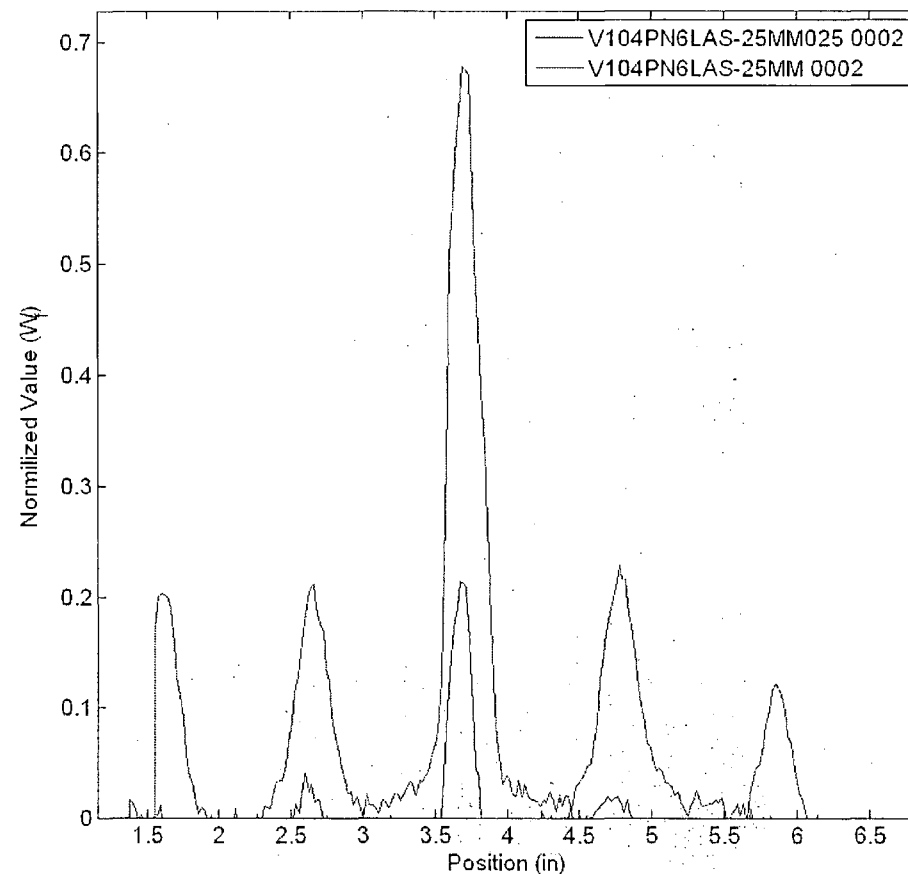
V104PN6LAS-25MM025 0002.RAW

Thermal Data – No T-Seal & 0.025" Gap 5/16"

Panel Number:6L - Gap - 0.025" Max Value:0.68

- The presence of the t-seal during thermographic inspection can have adverse masking affects on ability properly characterize defects that exist in the joggle region of the RCC panels. This masking affect dictates the final specialized inspection should be preformed with the t-seal removed.

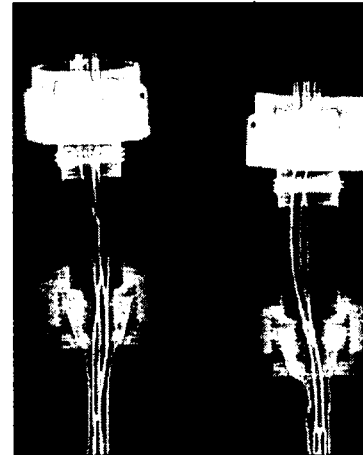
**Small connectors:
Individual pins visible**

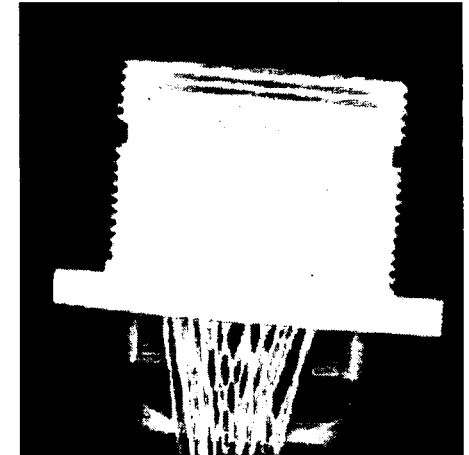
**Multi-pin connectors:
Pins superimposed**

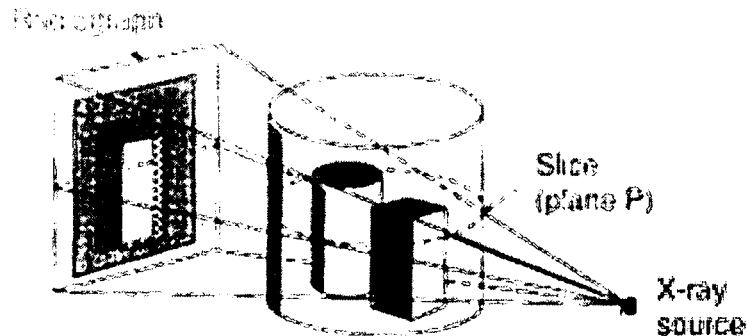
- Digital geometry processing is used to generate a three-dimensional image of the inside of an object from a large series of two-dimensional X-ray images taken around a single axis of rotation.
- CT produces a volume of data which can be manipulated, through a process known as "windowing", in order to demonstrate various bodily structures based on their ability to block the X-ray beam.

**Specimen to be inspected rotates within x-ray beam.
Duration of rotation (currently 4.4 hours) will be
reduced to 8 minutes with faster detector.**

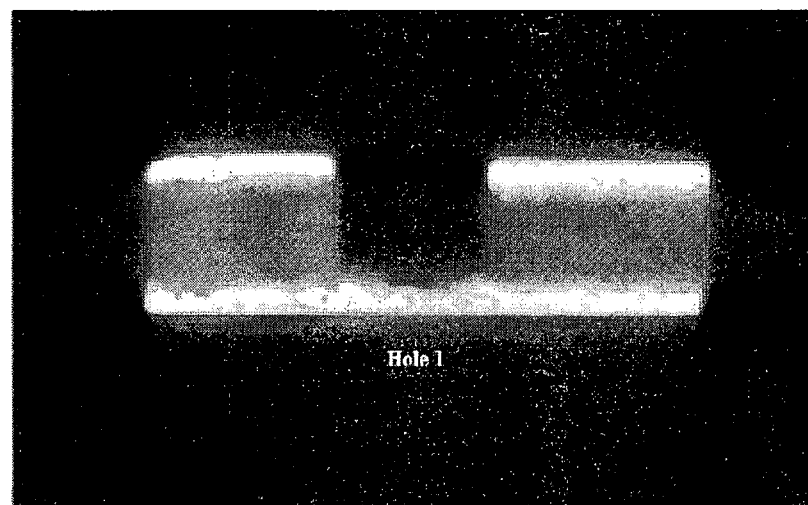
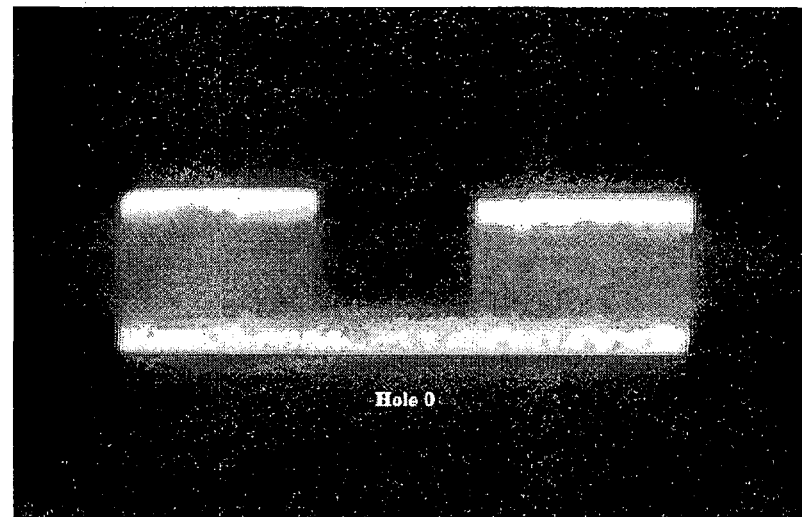
X-ray machine: Philips MG225
(positioned stationary on floor - independent of part manipulator)
Focal spot: small = 0.6 mm
No collimator
Source to center of rotation distance: 55.75 inch
Center of rotation to detector front distance: 7.625 inch
Tube filter: 0.010 inch lead
Detector: Thales FS35 (14 bit, 0.127 mm pixel pitch, fine scintillator)
Detector frame time knob set to 15 (equivalent to approx. 4 sec per frame)
Software: Hytec DAQ 3.1.0, DPS 2.0.6, VIZ: 3.0.3
Hytec part manipulator FCT-P101 (3-axis)
Detector mounted to Hytec part manipulator
Hytec reconstruction cluster with 8 processors

180 kV, 3.75 mA
Detector masked with lead except for region of connector to avoid artifacts from aerial saturation
Detector calibration strip also masked with lead
4 frames averaged per turntable position
1,000 turntable positions = 0.36 degrees between positions (software suggested ~700 based on crop region width)
Scan duration: 4 hours 25 minutes per connector

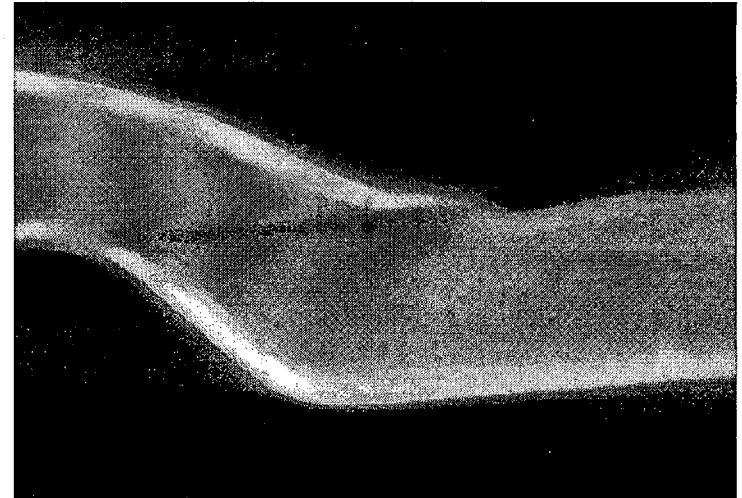
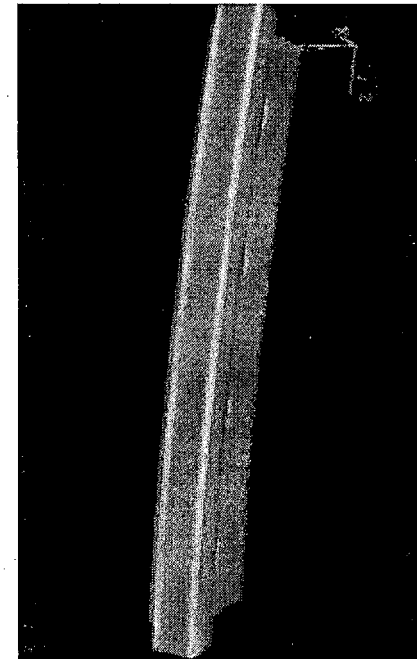
- USA NDE has the capability to perform CT on large panels.
- We do have some beam hardening due to a lack of energy in some regions of the panels.
- The resolution of the system is very high on the order of microns.
- We also perform CT on RCC repair samples that come from JSC.
